# Pond System Management Plan

## Winslow Farm Community Association Perry Township, Monroe County, Indiana

July 2018

Prepared by:  
Davey Resource Group  
5641 West 73<sup>rd</sup> Street  
Indianapolis, Indiana 46278  
317-558-8545

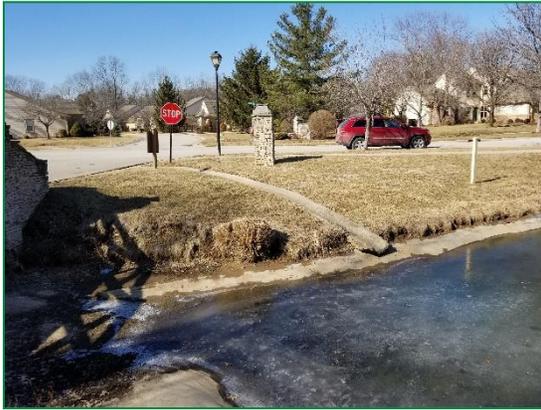
*Pond 4 Southwest Bank*

Pond 4 was roughly 6 inches below the culvert elevation. Much of the liner was exposed during the February site visit. Cracks were visible near the top of the liner exposing soil underneath. Exposed liners are likely a result of damage to the liner as well as shoreline erosion from mowing to the water's edge. Stormwater infrastructure (inlet pipes and concrete conveyances) mark the old shoreline location (photographs below).

Davey Resource Group recommends restoring the shoreline by placing top soil on top of exposed liners along the water's edge. Stone can be placed at the base of the shoreline to provide extra protection. Soil has fallen from the shoreline into the pond system overtime due to repeated exposure to the weight of mowing equipment. Soil for restoring the shoreline may come locally from dredged soils. Davey Resource Group recommends restoring the banks and replacing damaged liners at the same time any dredging occurs. Agency coordination should occur prior to placing any soil on the shorelines. Restoring the shoreline without replacing pond liners is recommended in Ponds 6-7. The same stone installation previously performed by Evergreen Home Improvement, LLC in Pond 7 could be used for the rest of Pond 7 and the entirety of Pond 6. Permitting agencies should be consulted before performing this activity. Davey Resource Group contacted Evergreen Home Improvements for a cost estimate to perform this work in other areas of the pond system, but the company was not forthcoming with pricing information. WFCA should contact Evergreen Home Improvement for a cost estimate to install top soil and stone along the shoreline of Ponds 6 and 7.
