# Pond System Management Plan

## Winslow Farm Community Association Perry Township, Monroe County, Indiana

July 2018

Prepared by:  
Davey Resource Group  
5641 West 73<sup>rd</sup> Street  
Indianapolis, Indiana 46278  
317-558-8545

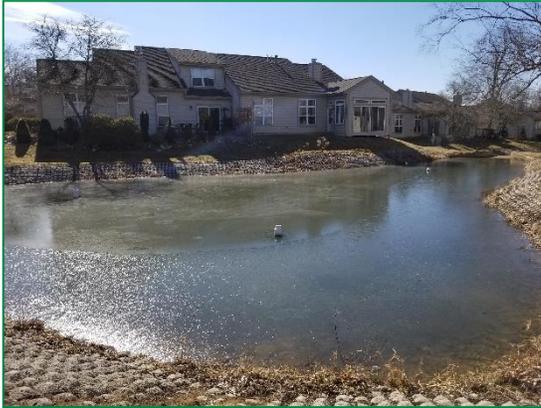
*Pond 1*

Pond 1 is the upper-most waterbody in the system. The pond is located west of the East Winslow Farm Drive and South Highland Avenue intersection. The pond is approximately 0.11 acre with an average depth of 2 feet. Three aerators are installed in the pond to create adequate mixing for improved dissolved oxygen levels.

Water inputs into Pond 1 include runoff from South Highland Avenue, stormwater pipes from surrounding residences, and through a water pump in Pond 7 creating a continuous loop in the pond system. A silt trap was installed at the inflow from South Highland Road in September 2017 to filter soil and rock particles from water moving into the system. Other recent work in the pond includes dredging in 2015 and a new pond liner and shoreline repair with Flexamat installation in the fall of 2016. Approximately three feet of muck was taken out of the pond at the time of dredging according to local membership and management staff.

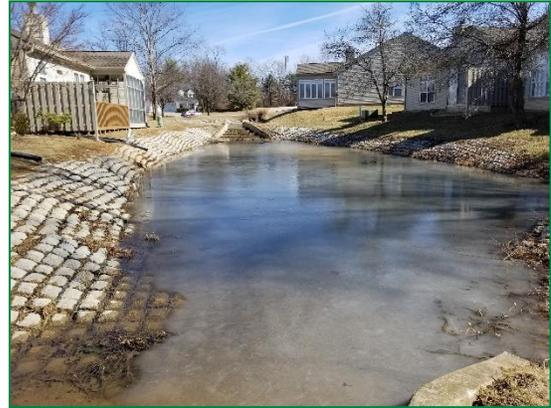
*Pond 2*

Pond 2 is located immediately west of Pond 1. The pond is approximately 0.10 acre with an average depth of 2 feet. No fountains or aerators may be found in Pond 2.

Pond 2 receives incoming water from Pond 1 through a weir. The weir was resealed on June 2017 to prevent loss of water in the pond system. Other recent work in the pond includes new pond liner and shoreline repair with Flexamat installation in the fall of 2016.

Up to three feet of muck was taken out of the pond at the time of dredging according to local membership and management staff.

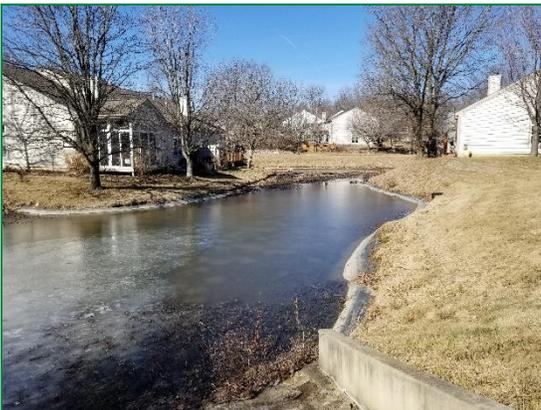
*Pond 3*

Pond 3 will fill in slowly with sediment as time passes. Wetland vegetation will slowly migrate south through the pond as it fills with sediment. WFCAs will need to stay on top of invasive species control during this transition. Native wetlands possess tremendous beauty; however, they are easily overrun with invasive species such as cattails, reed canary grass, phragmites, and purple loosestrife.

A second option for Pond 3 includes dredging and installation of a new pond liner. More information specific to pond liners and dredging may be found in Low Water Level and Exposed Liner Section of this report. Both dredging (taking soil out of) and rain garden installation (placement of fill material) could involve the need for USACE and IDEM Clean Water Act permitting based on the outcome of a jurisdictional determination. Dredging the southern half of Pond 3 will be more difficult once the rain garden is installed.

A third option would involve not moving material in or out of Pond 3. Wetland emergent seed could be spread along the bank in the northern half of the pond. Emergent vegetation would also serve to slow the water down and provide improved aesthetics in the area. This is an option with low cost; however, the chance of quick establishment of plant is low. Seed would have the ability to float around and travel out of the pond system. Emergent seed mixes normally cost between \$1,000-\$1,500 per acre from Spence Restoration Nursery. An example emergent seed mix maybe found within the Primrose Section of this report. If the seed is dispersed during a time with no water leaving the pond the chances of success increase.
